Manhole Inspection Summary

Manhole # S2111_017MH

Location Address: **2914 hollins ferry rd**

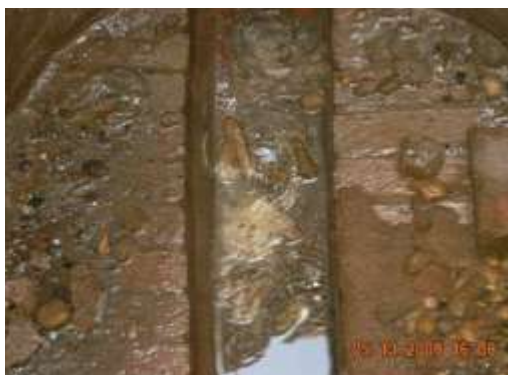
Defect 5

Condition: ☐ Sound ☐ Cracked ☐ Root Intrusion ☐ Deteriorated ☐ Leaks ☒ **Debris**

debris in channel

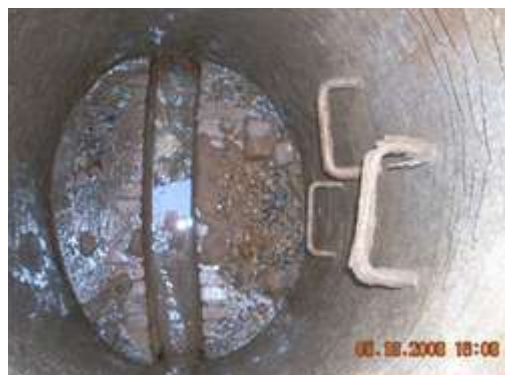
Defect 4

Condition: ☐ Sound ☐ Cracked ☐ Root Intrusion ☐ Deteriorated ☐ Leaks ☒ **Debris**

debris on bench

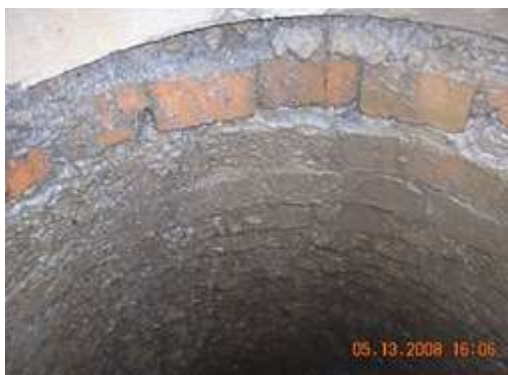
Defect 3

Condition: ☐ Sound ☐ Cracked ☐ Root Intrusion ☐ Loose Brick ☒ **Deteriorated**

Infiltration: ☐ None ☒ **Joint** ☐ Cracks ☐ Mortar ☐ Roots ☐ Wall

infiltration @ chimney/frame joint,
chimney deteriorated

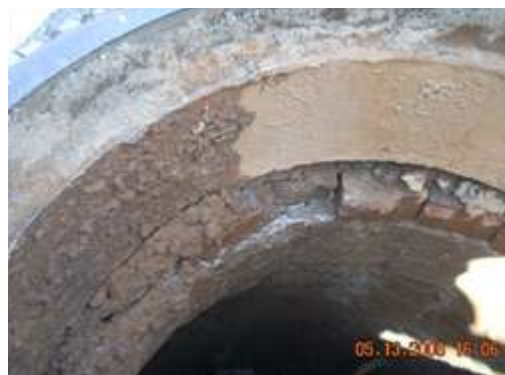
Defect 2

Frame Offset: **0** (in.) Condition: ☐ Sound ☐ Cracked ☒ **Leaks**

inflow evidence, frame leaking (mud)

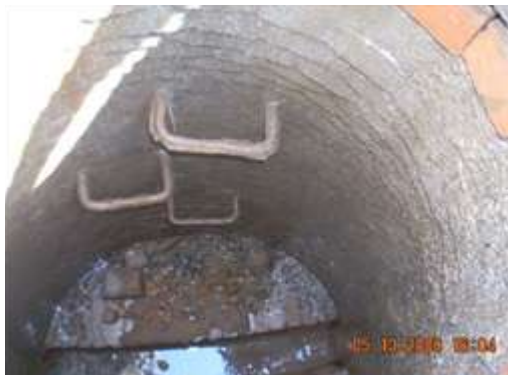
Defect 1

Steps Count: **3** Missing: **0** ☒ **Corroded**

corroded steps

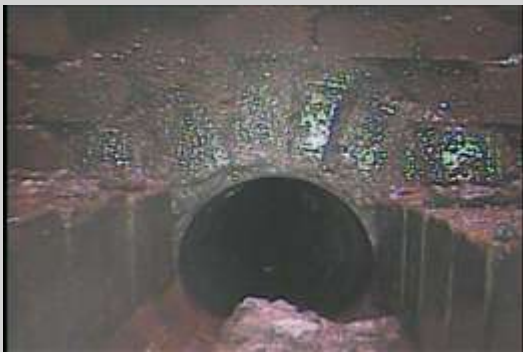
12 O'Clock Outflow

8 in. Circular Gravity Sewer
Pipe Out @ 12 O'Clock

Pipe Height: **8.4** (in.) Rod and Bar (Angled)
Pipe Material: **Clay** ☐ Pipe Lined
Invert Depth: **8.14** (ft.) Flow Characteristics: **Slow**
Deposits: ☒ None ☐ Mud ☐ Sludge ☐ Debris ☐ Grease
Silt Depth: **0** (in.) Deposits Extent:
Infiltration: **None** Pipe Seal Cond: **Sound**

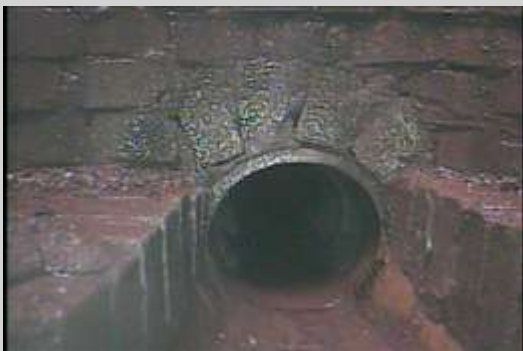
6 O'Clock Inflow

8 in. Circular Gravity Sewer
Pipe In @ 6 O'Clock

Pipe Height: **8.4** (in.) Rod and Bar (Angled)
Pipe Material: **Clay** ☐ Pipe Lined
Invert Depth: **8.04** (ft.) Flow Characteristics: **Slow**
Deposits: ☒ None ☐ Mud ☐ Sludge ☐ Debris ☐ Grease
Silt Depth: **0** (in.) Deposits Extent:
Infiltration: **None** Pipe Seal Cond: **Sound**
